Recreational Use Attainability Analysis for Buffalo Creek (0214B), Paradise Creek (0230A), and Sweetwater Creek (0299A) in the Red River Basin

DRAFT for PUBLIC REVIEW

Prepared for:
Texas State Soil and Water Conservation Board
Project 12-52

TR 1308

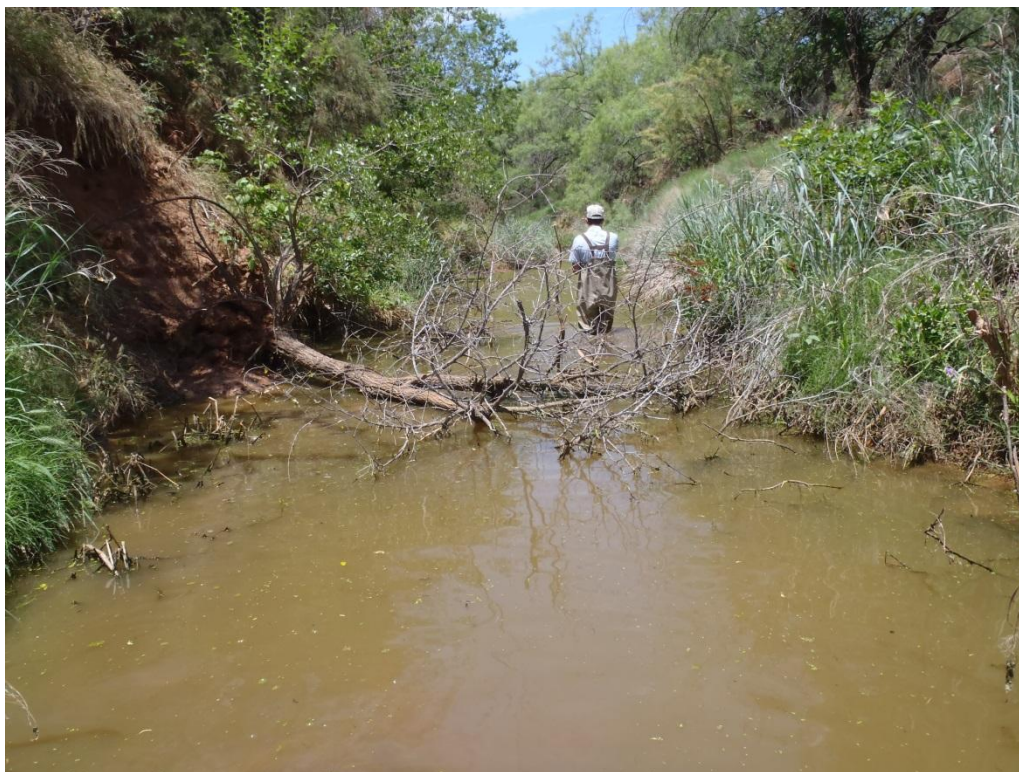
Figure 3.4 Photograph of Buffalo Creek at Site BF001 taken June 8, 2013, downstream view at 40-m. Note log obstruction, dense vegetation and steep banks. TIAER personnel in photograph.

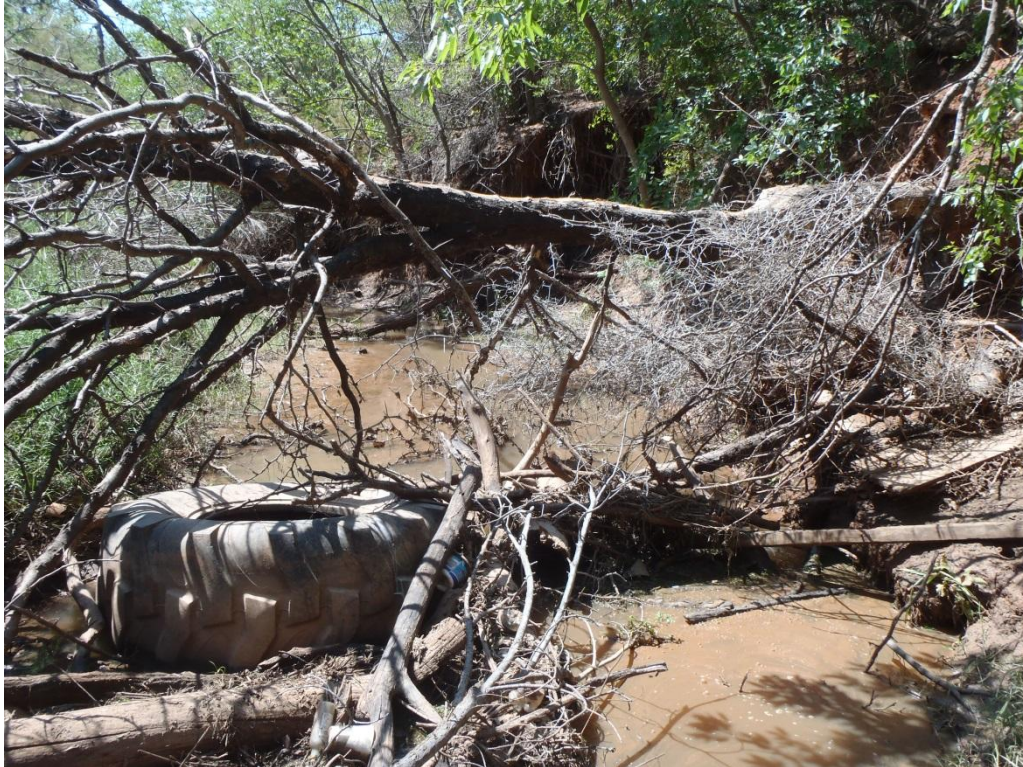
Figure 3.6 Photograph of site BF002 taken July 20, 2013. Downstream view at 30-m transect. Note log and large garbage obstructions.

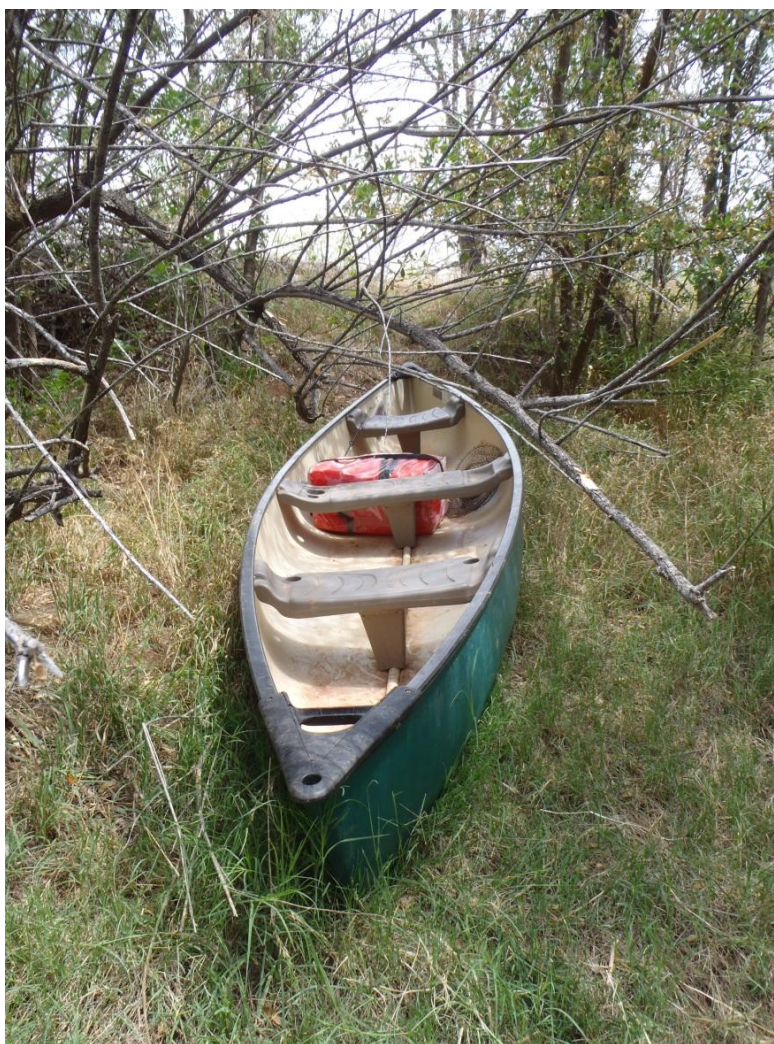
Figure 3.7 Photograph of Site BF002 taken June 8, 2013 of canoe on left bank approximately 150-m from bridge.

No contact (primary or secondary) or noncontact recreational activities were observed by TIAER employees at any of the sites during the field surveys. The only evidence field personnel found of any possible recreation occurring was at Site BF002. A canoe and a pack with unknown contents were found on the bank of the stream (Figure 3.7). No evidence of recreation was found at any of the other sites.

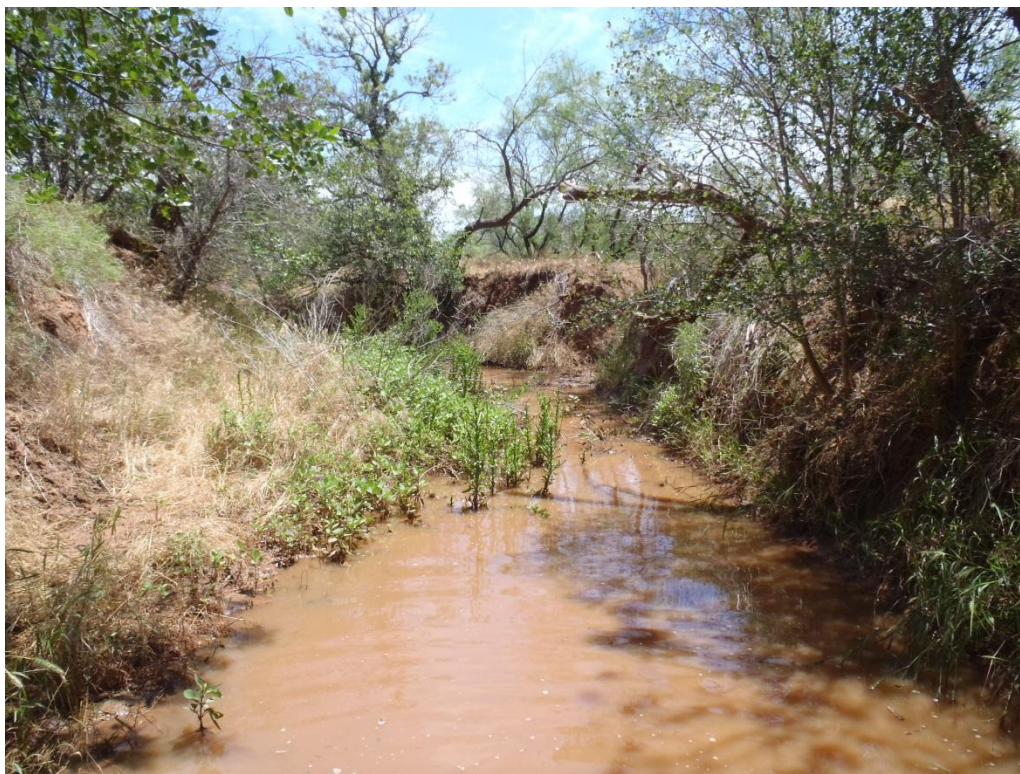
Figure 3.11 Photograph of Site BF004, downstream view at 30-m transect. Note steep banks on right side and more gradual bank on left.

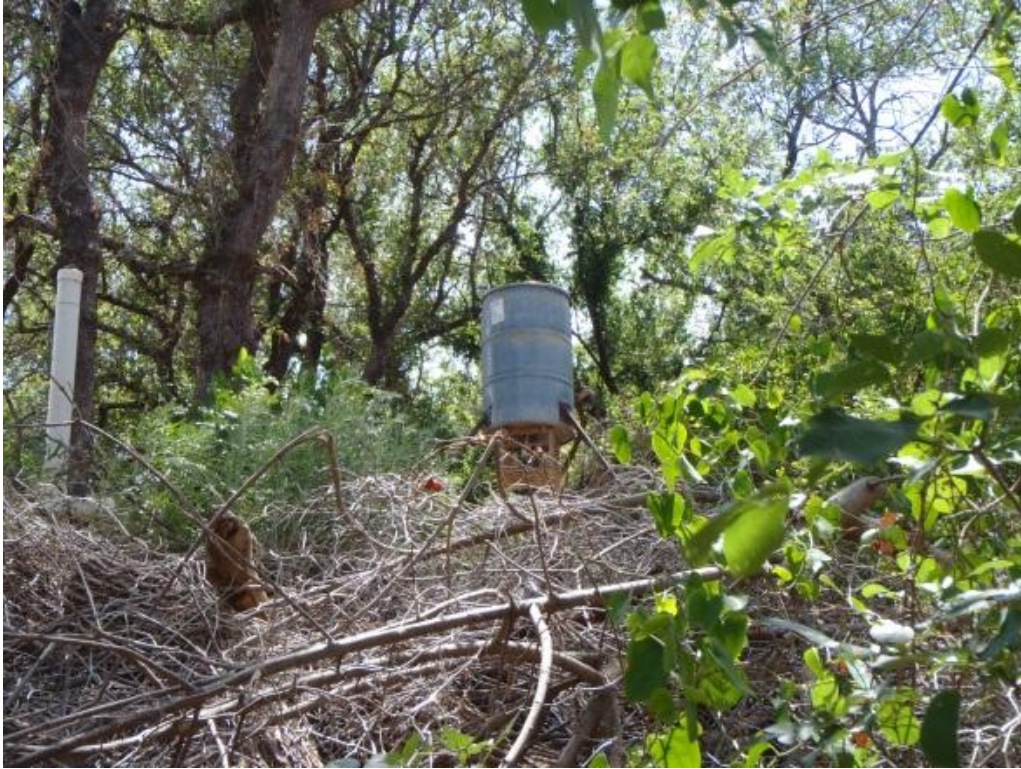
Figure 3.16 Photograph of BF005, taken on June 8, 2013, deer feeder at 210-m.

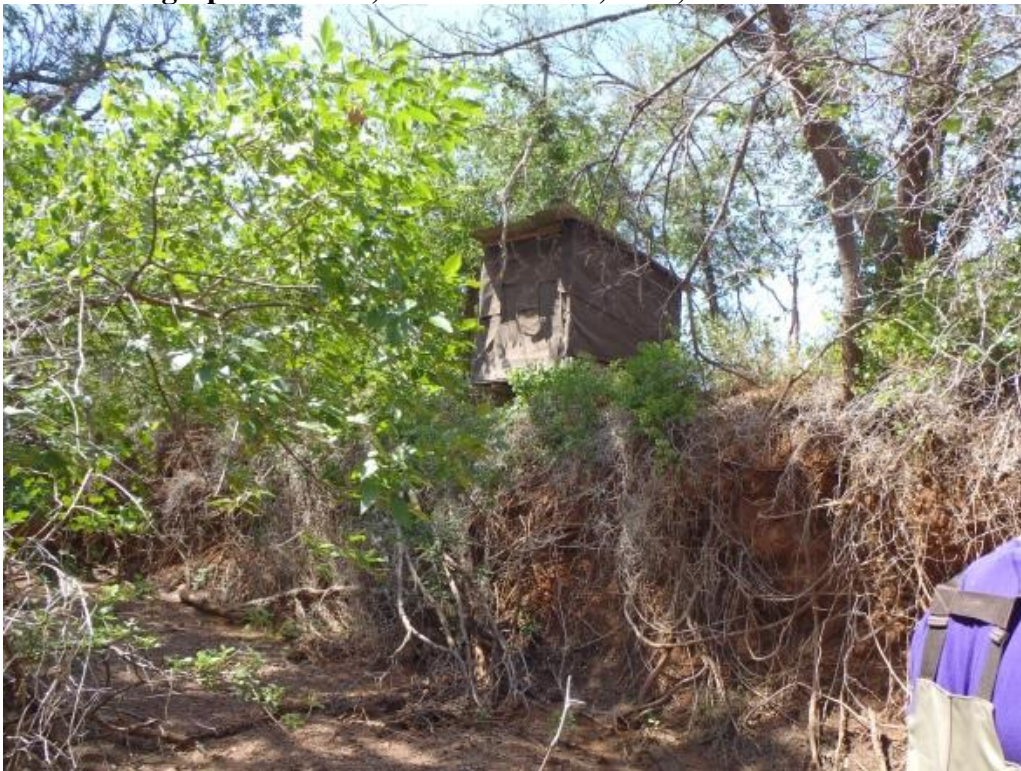
Figure 3.17 Photograph of BF005, taken on June 8, 2013, hunting blind at 210 m. TIAER personnel in photograph.

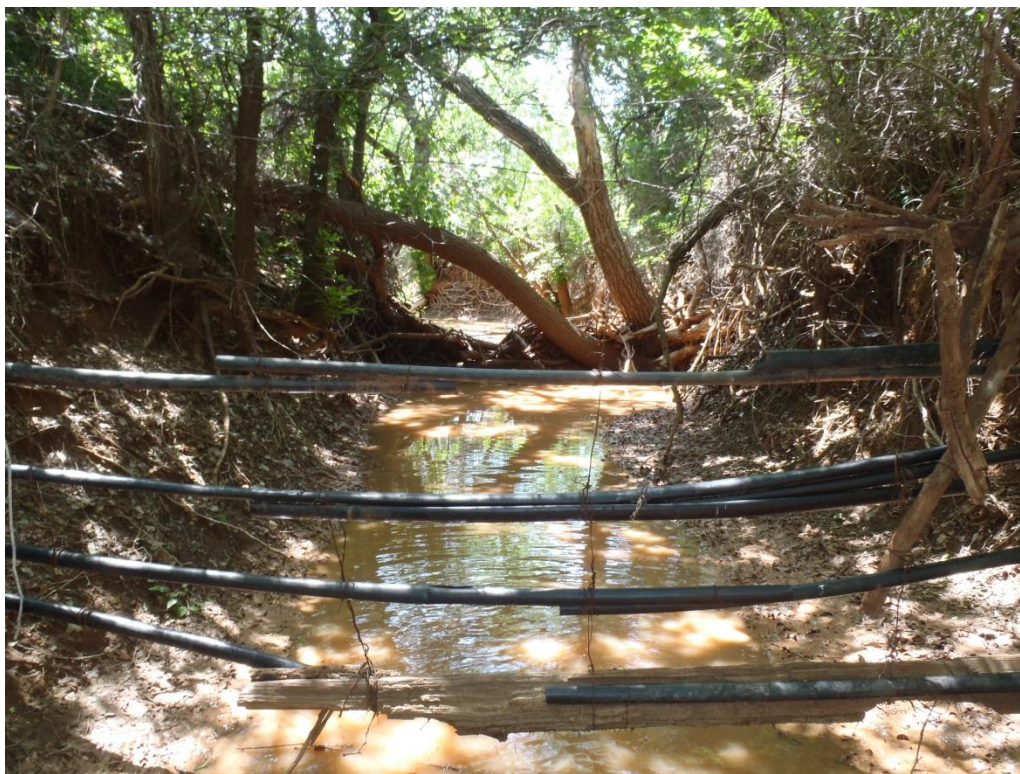
Figure 3.18 Photograph of Site BF006 taken June 8, 2013, upstream view at 300-m transect with a fence intersecting the stream.

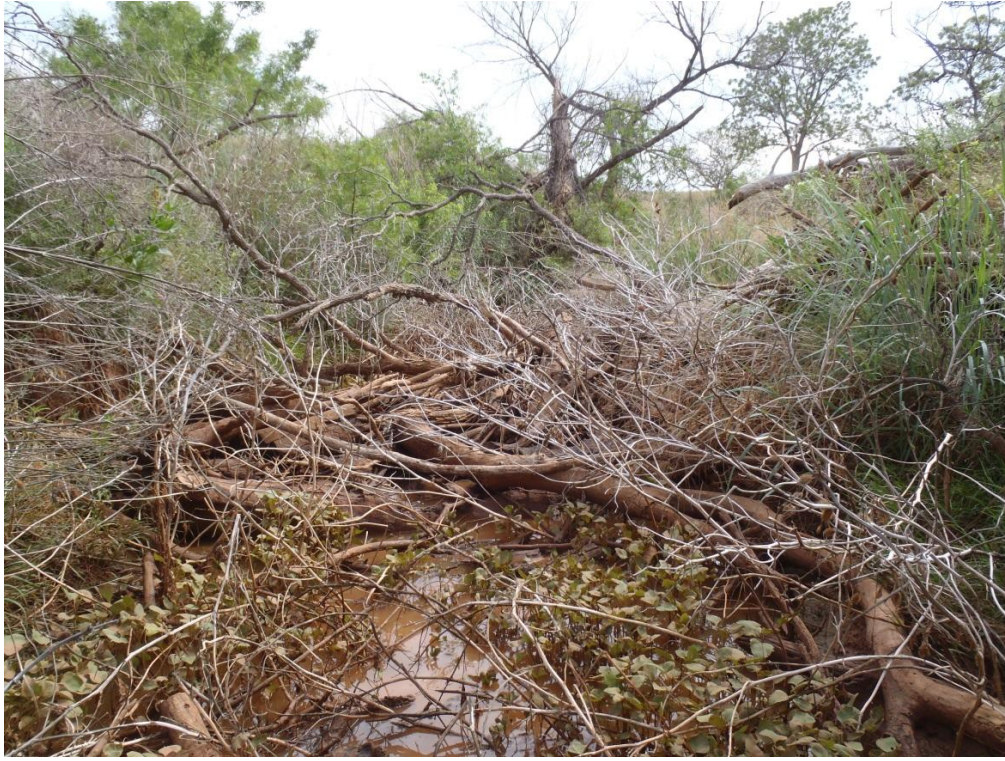
Figure 3.20 Photograph of Site BF007 taken on June 8, 2013, downstream view at a large debris accumulation in the stream at the 150-m transect.

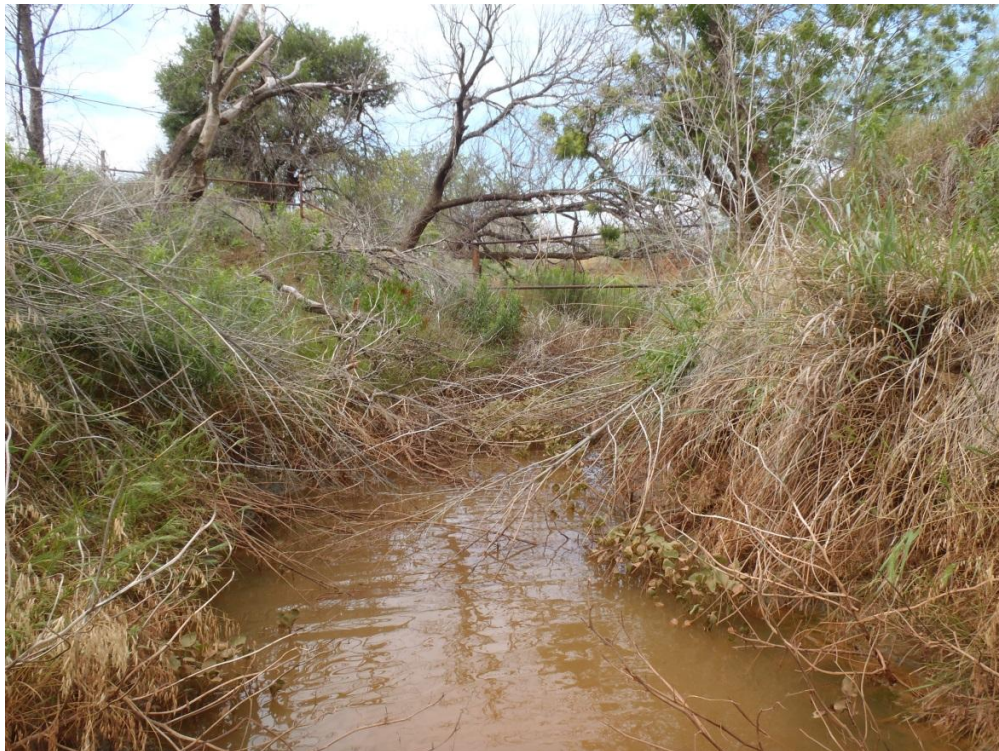
Figure 3.21 Photograph of BF007 taken on June 8, 2013, upstream view at 300-m transect. Note steep vegetated banks and cross fence with welded wire water gap.

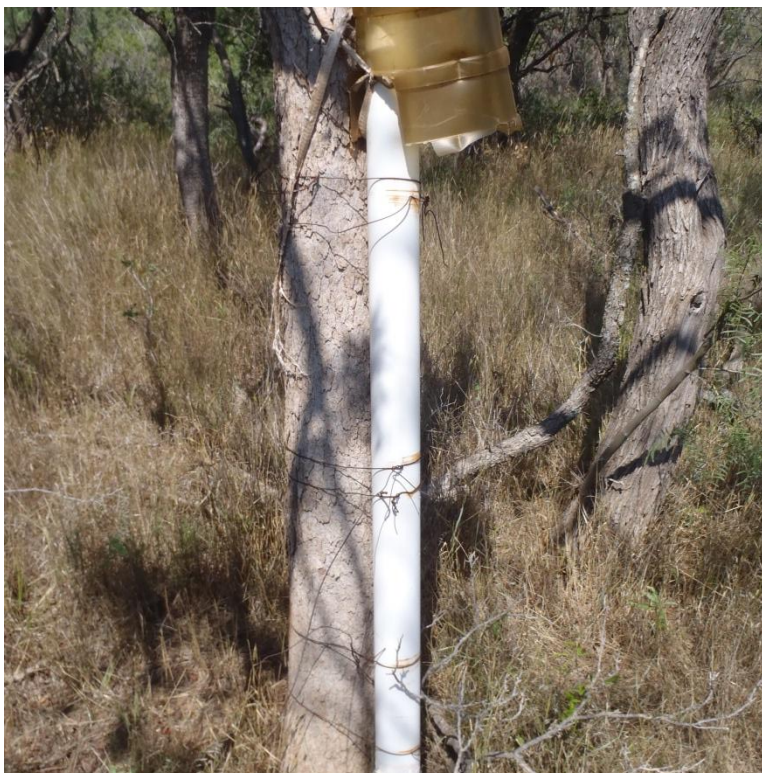
Figure 3.22 Photograph of BF007 taken on July 20, 2013, PVC gravity corn feeder wired to a tree.

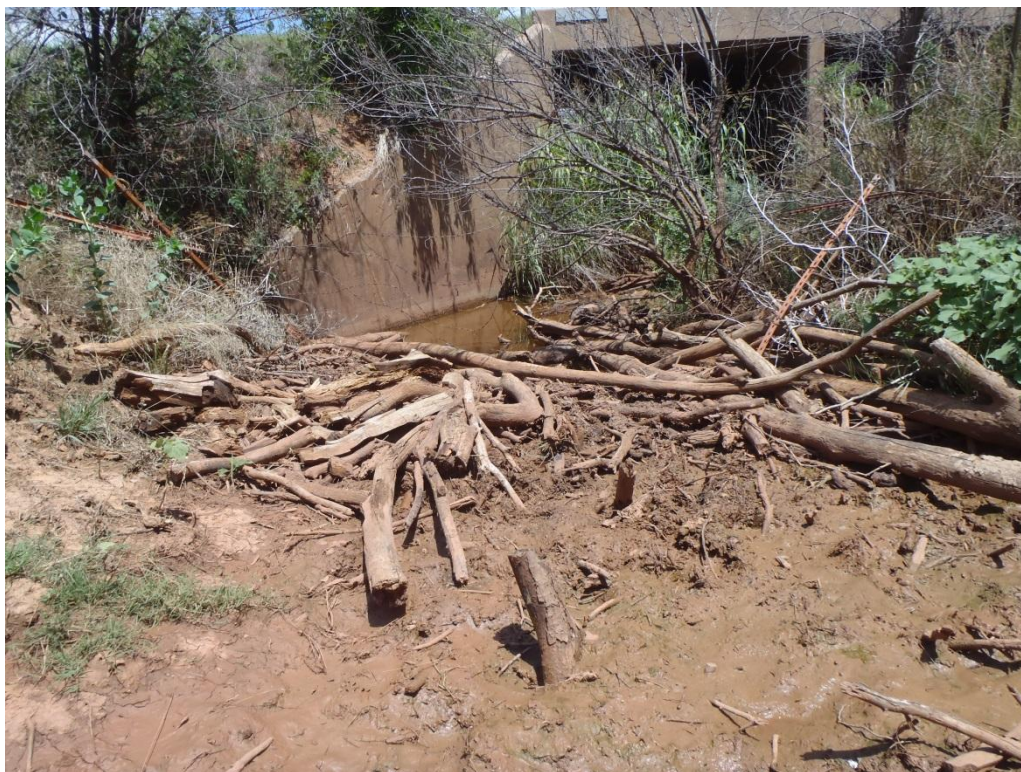
Figure 3.23 Photograph of BF008 taken on July 20, 2013 downstream view at 30-m transect. Note private barbed wire fence line and log jam.

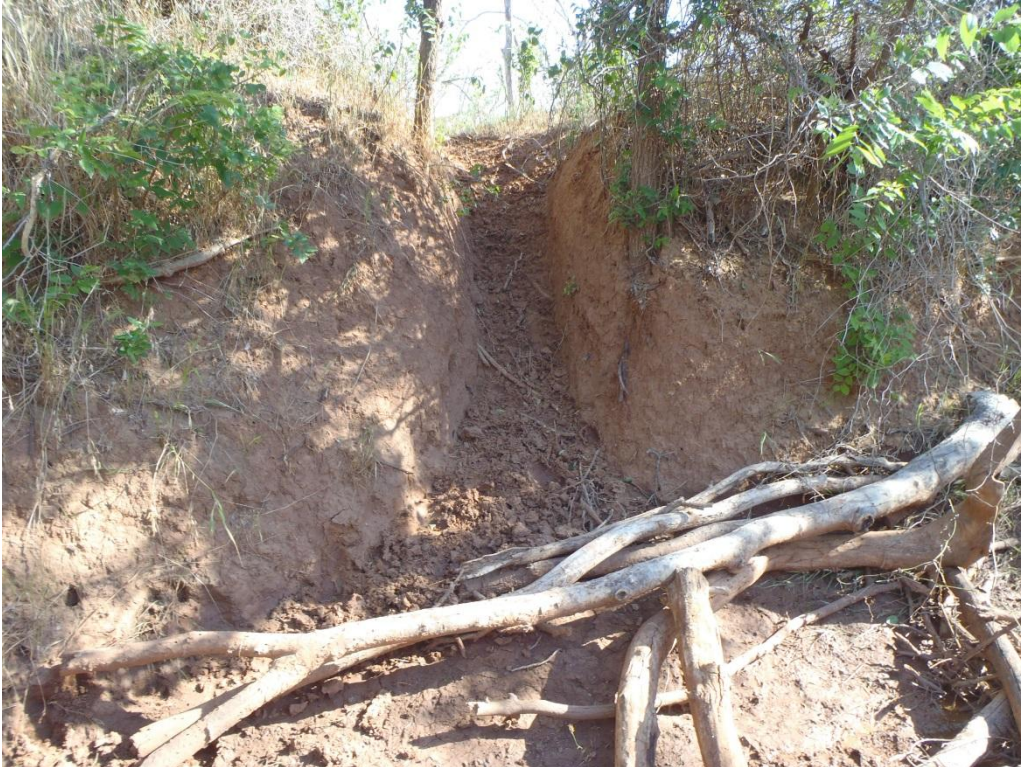
Figure 3.25 Photograph of BF008 taken on June 8, 2013 of wildlife and livestock travel corridor leading into creek.

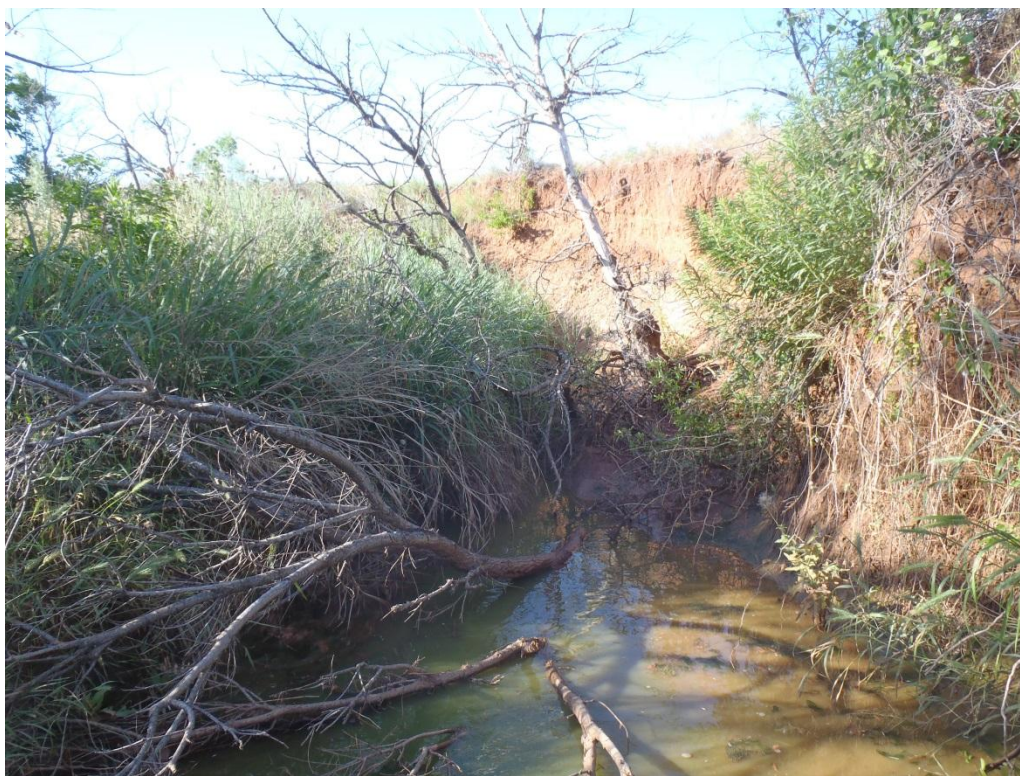
Figure 3.26 Photograph of site BF009 taken on June 8, 2013, upstream view at 30-m transect. Note the steep banks, water levels and debris.

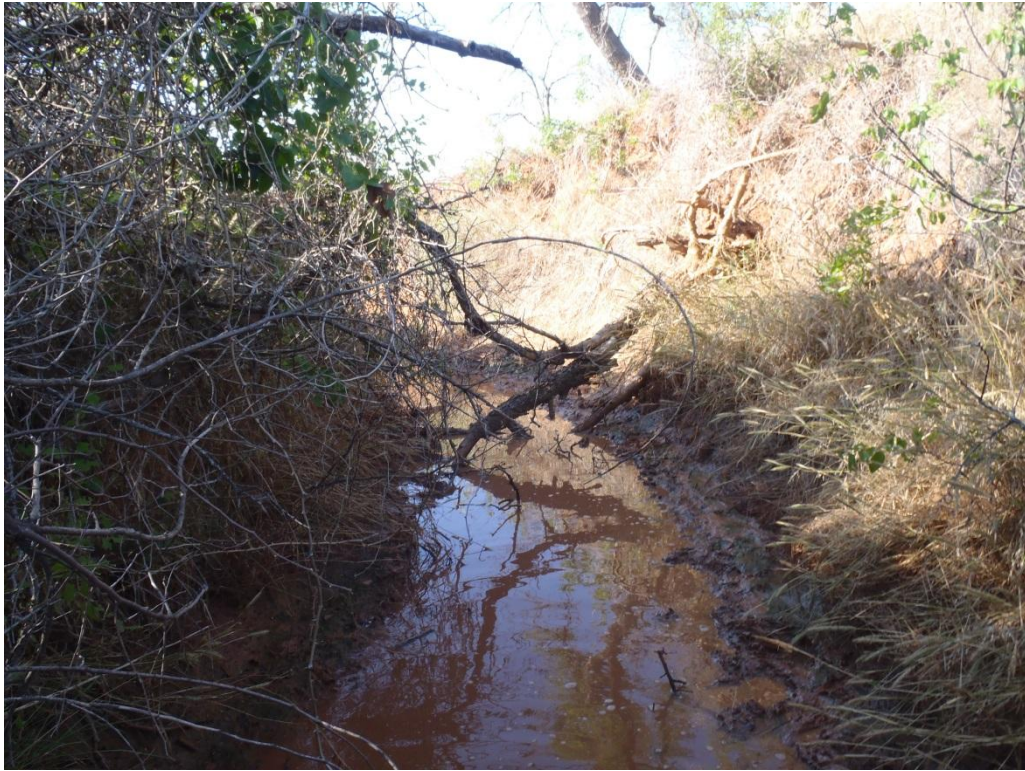
Figure 3.27 Photograph of site BF009 taken on July 20, 2013, downstream view at 150-m transect. Note narrow channel, steep banks and dense vegetation on the left.

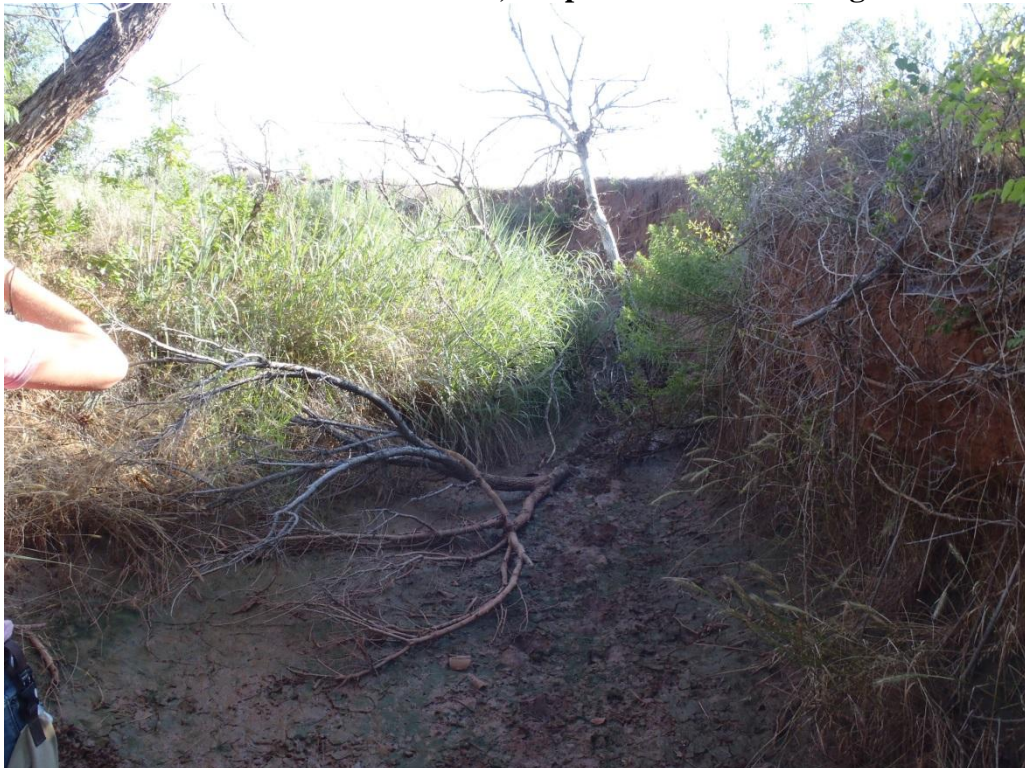
Figure 3.28 Photograph of site BF009 taken on July 20, 2013, upstream view at 30-m transect. Note absence of water and debris. TIAER personnel in photograph.

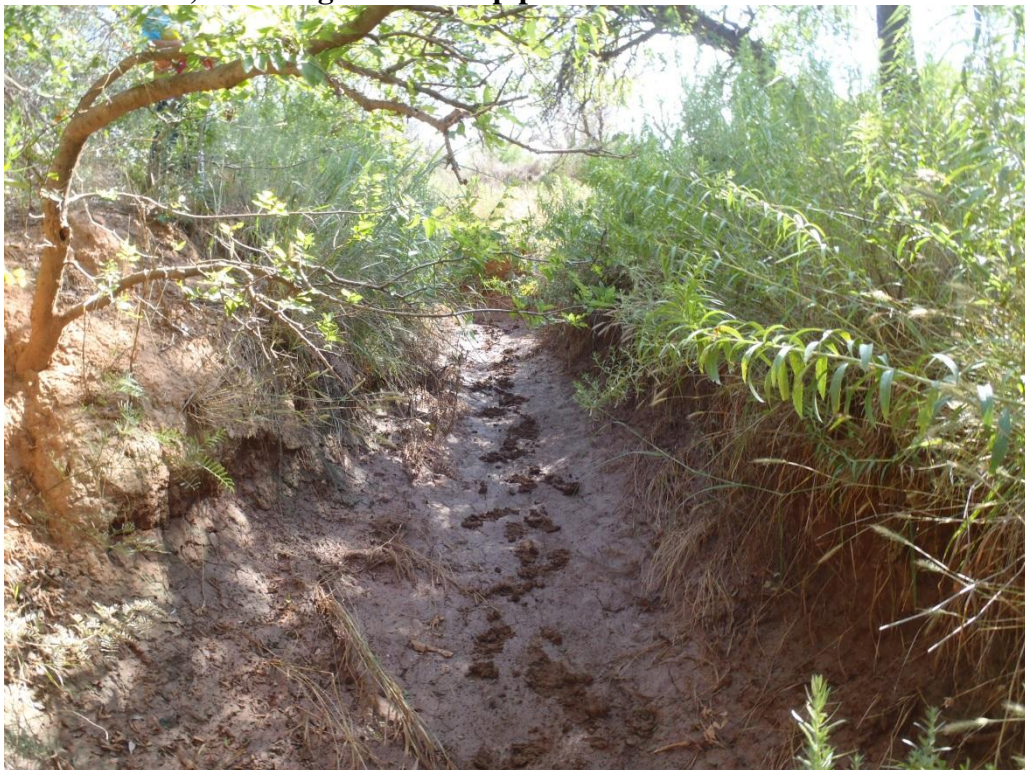
Figure 3.30 Photograph of BF010 taken on July 20, 2013, upstream view at 30-m transect. Note lack of water, muddy substrate, dense vegetation and steep banks.

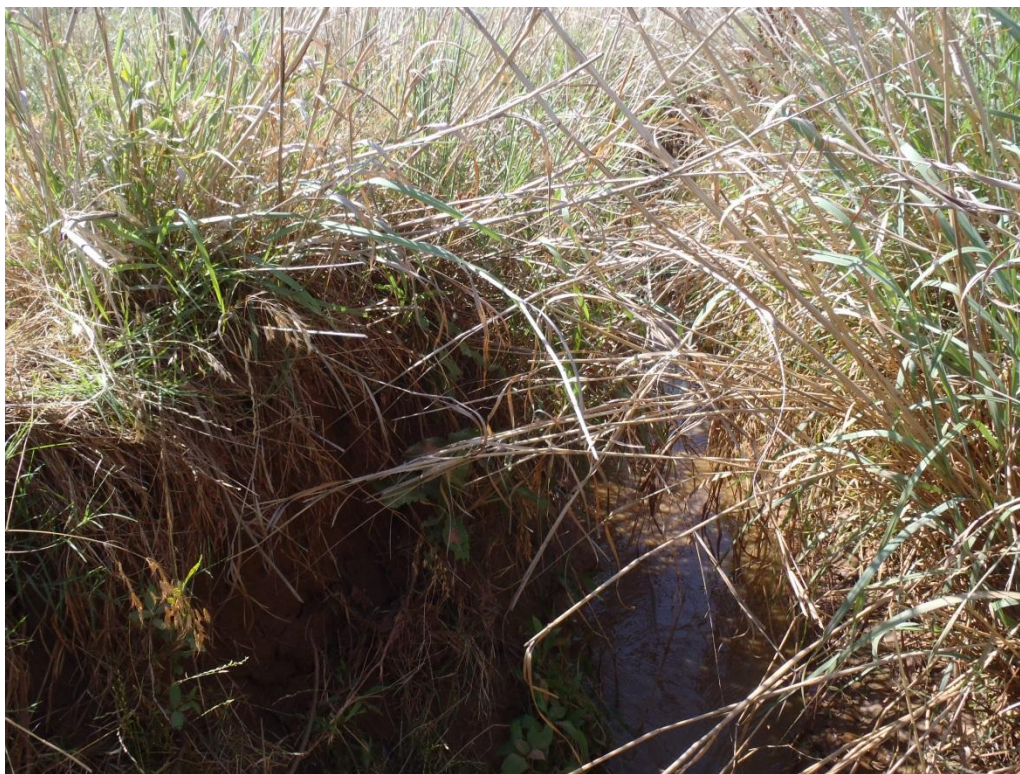
BF011 was surveyed on June 8 and July 21, 2013. Access to this site was easy because it occurred at a road crossing. However, access into the stream was moderately easy after acquiring landowner permission to cross a fence that bisected the creek. The creek at this site cut a narrow channel with dense bunchgrass vegetation on the banks but did not significantly impede travel through the corridor (Figure 3.31).

Figure 3.31 Photograph of site BF011, upstream view at 150-m transect. Note narrow channel and thick vegetation.

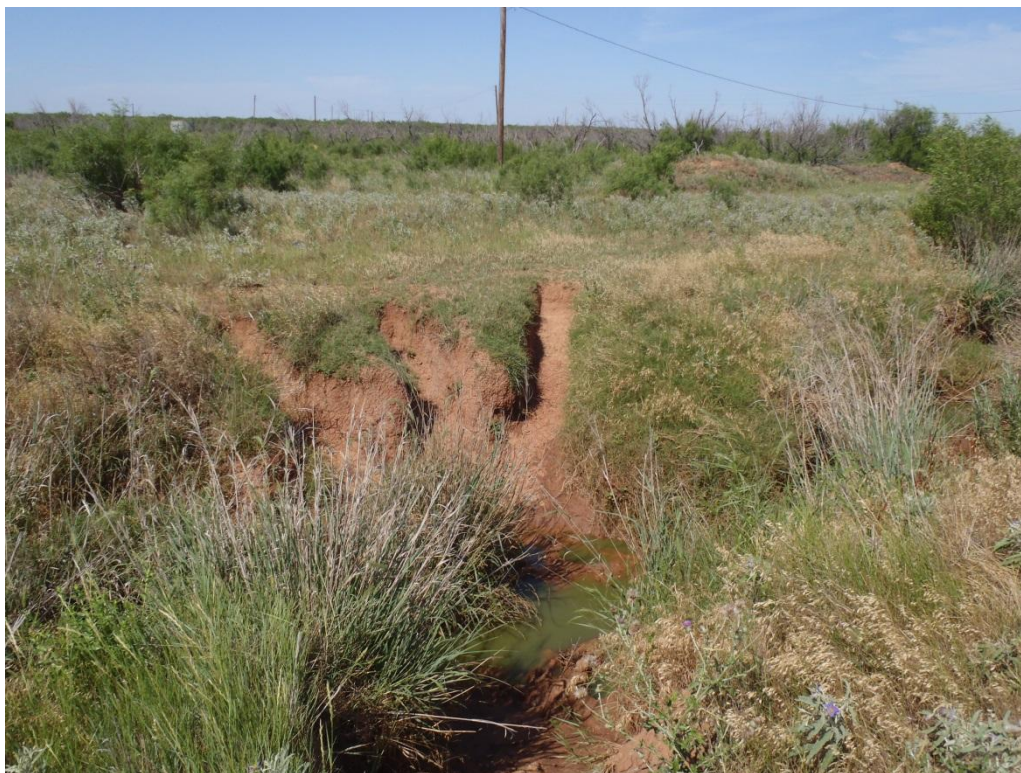
Indications of wildlife presence included tracks of raccoon, canine, bird, deer and turtle. Fecal material of bird, cattle, and some of unknown origin was documented. Bones of a deceased cow were seen and the call of a bobwhite quail was heard. At the 110-m transect a livestock trail was observed crossing through the creek (Figure 3.32) and evidence of a depredated turtle nest was observed. Although garbage was rarely seen at this site, a plastic oil can and styrofoam were

Figure 3.32 Photograph of BF011 taken on June 8, 2013, of a livestock crossing at 110-m transect.

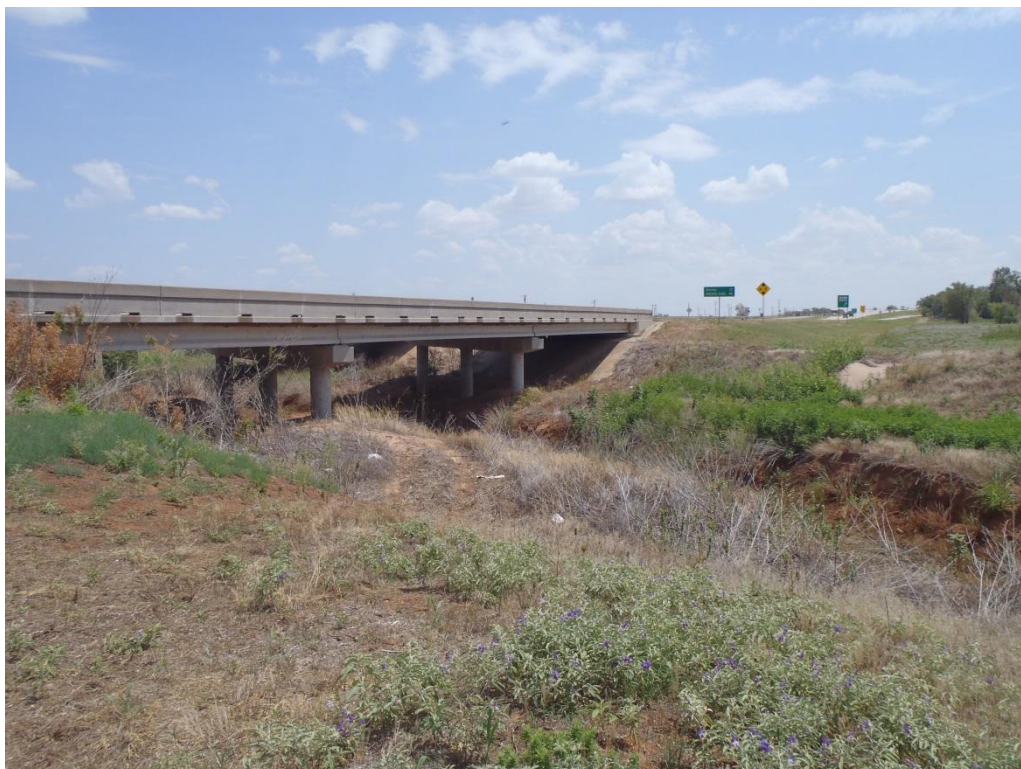
Site PD001 was surveyed June 9 and August 11, 2013. Access to this site was moderately easy as it was located at State Highway 287, which has a wide shoulder and no private fencing to cross (Figure 4.6). The primary hindrance was the muddy substrate making wading slightly difficult (Table 4.5).

Figure 4.3 Photograph of PD001 taken on August 11, 2013 of public access point at the creek and Hwy 287.

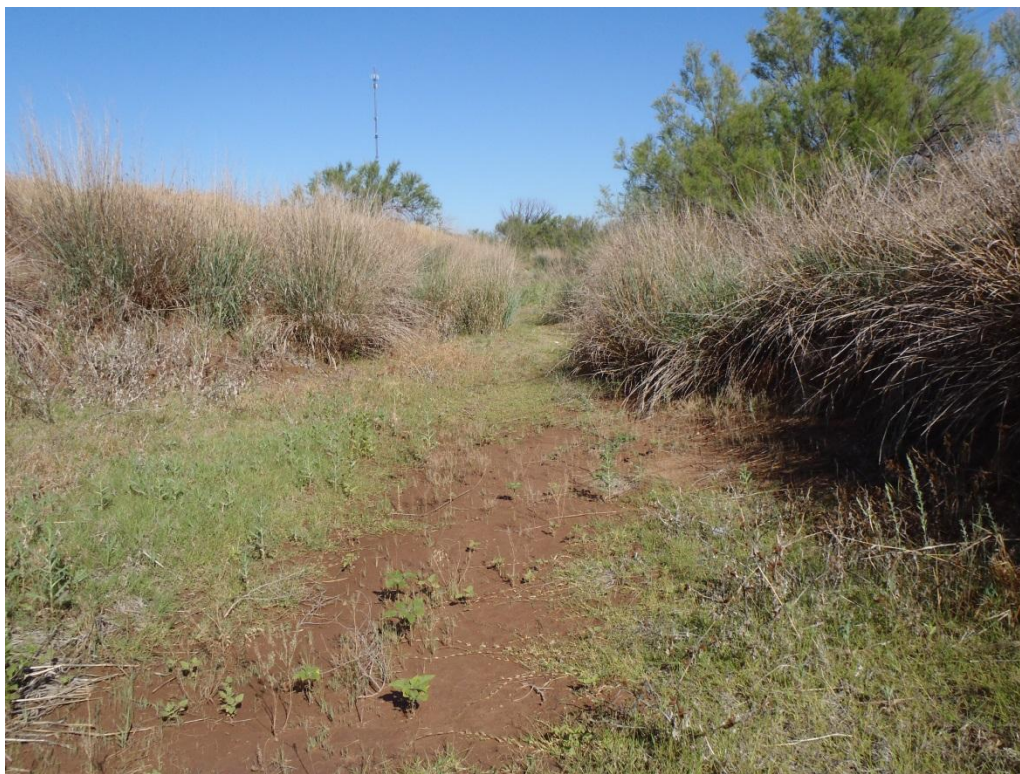
The stream channel was well defined and naturally vegetated. Banks were steep and vegetated with switchgrass on the right bank, some trees on the left with pasture out away from the stream (Figure 4.4). The fine sediment substrate was slick when wet and caused sinking when wading in places. During the first survey, where water was present, the surface was clear of algae, clear in color with an occasionally detectable odor (Table 4.9). During the second survey, there was more water in the form of small pools. The surfaces of these pools were clear and brown in color with some algae, foam and scum. An oily sheen was observed in small amounts in a few places where water was present (Table 4.10).

Figure 4.4 Photograph of site PD001 taken June 9, 2013, upstream view at 300-m transect. Note steep banks dominated by dense switchgrass.

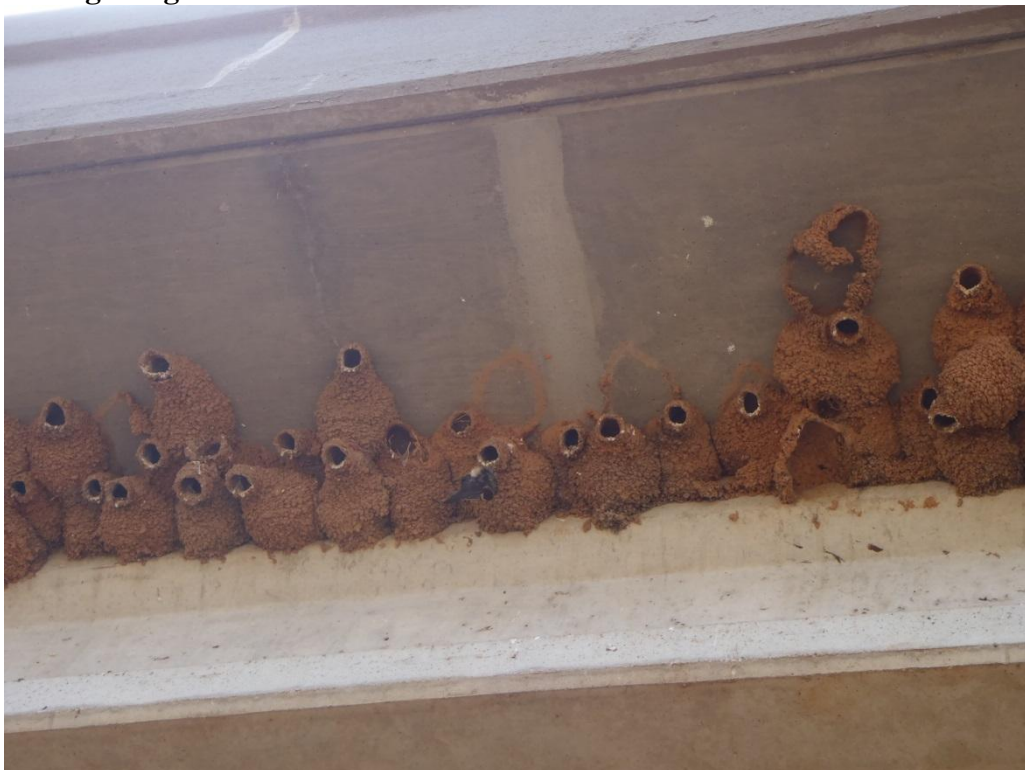
Figure 4.6 Photograph of PD001 taken on August 11, 2013 of cliff swallow nests under Hwy 287 bridge.

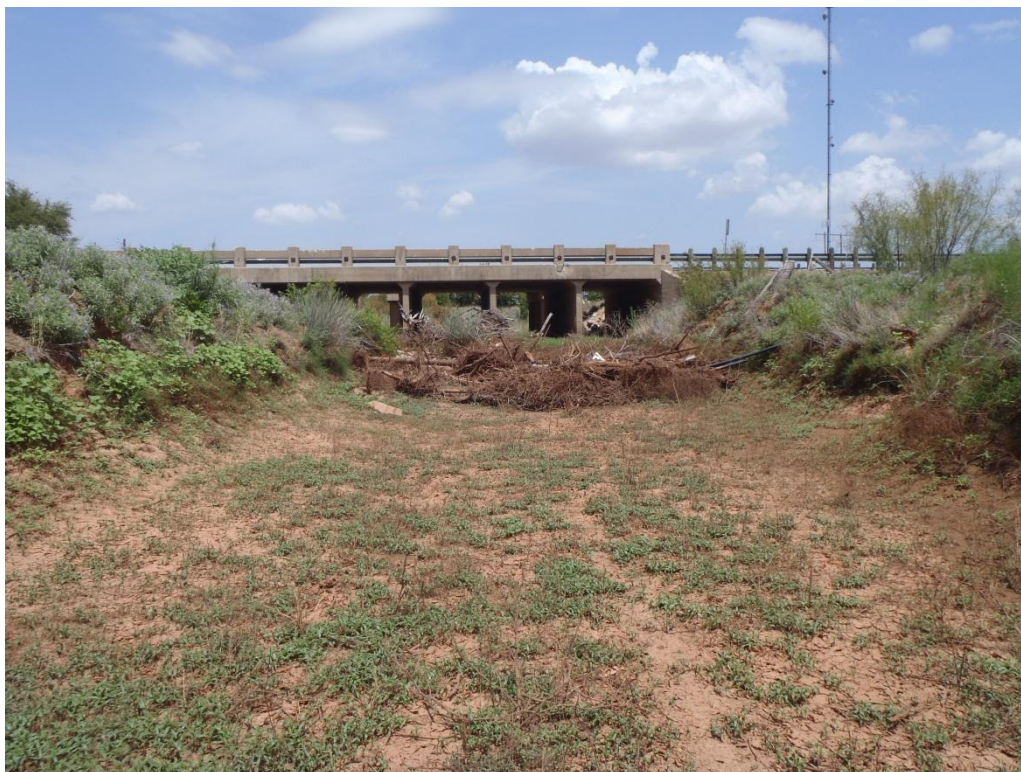
This site was surveyed on June 9 and August 11, 2013. Public access at the bridge made entering the stream moderately easy (Table 4.6). However, crossing a private fence through a large accumulation of debris in the stream bed within the first 30 m created an initial challenge to complete the 300-m survey (Figure 4.7). Average thalweg depths of the reach were 0.00 m during the first survey and 0.00 m during the second survey (Table 4.6).

Figure 4.7 Photograph of PD002 taken on June 9, 2013. Downstream view at the 30-m transect. Note the public access point at the bridge and debris piled up at the private fence line.

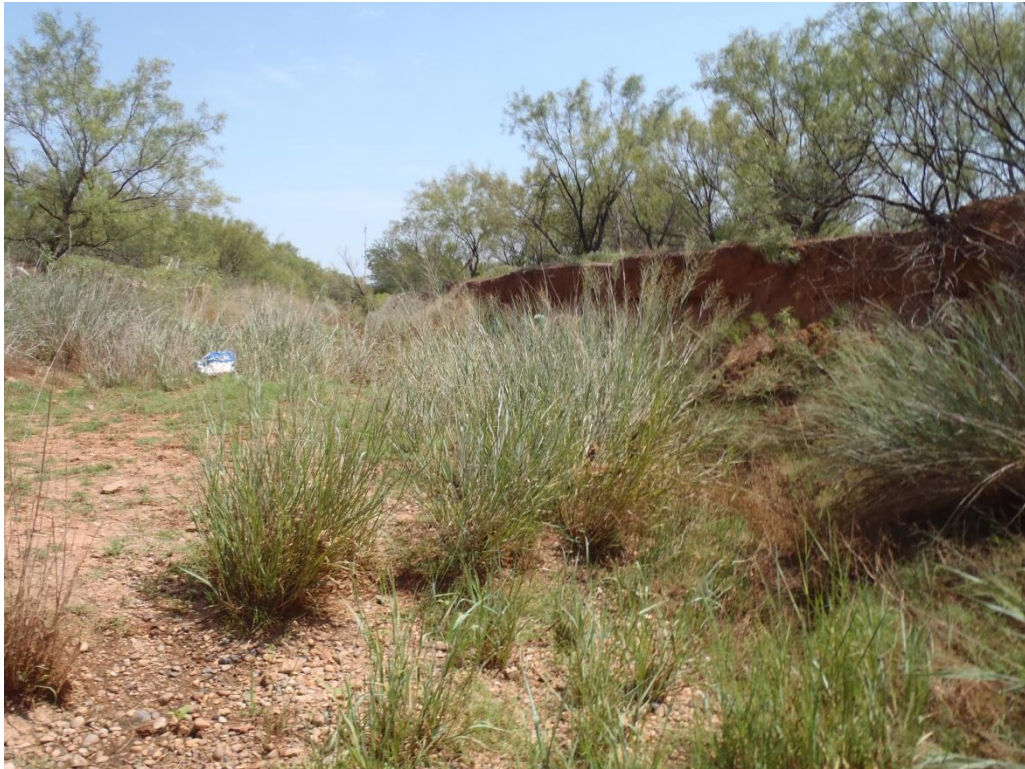
The banks were steep in some places and vegetated with switchgrass, willow trees and some cottonwoods opening up to pastureland past the edges of the riparian area (Figure 4.10). Some stretches of the stream bottom were vegetated with grasses as well. Evidence of beaver was observed in the form of gnaw marks on trees. A dead snake and shells of bivalves were seen. Horse and bird manure as well as tracks of raccoon, deer, and dog were observed in the stream bed. Garbage was rare at this site and included a tractor tire (Figure 4.11), some aluminum cans, and bottles (Tables 4.9 and 4.10). No evidence of human recreation was observed at this site.

Figure 4.10 Photograph taken of PD003 on August 11, 2013. Downstream view at the 30-m transect. Note vegetated streambed, steep right bank.

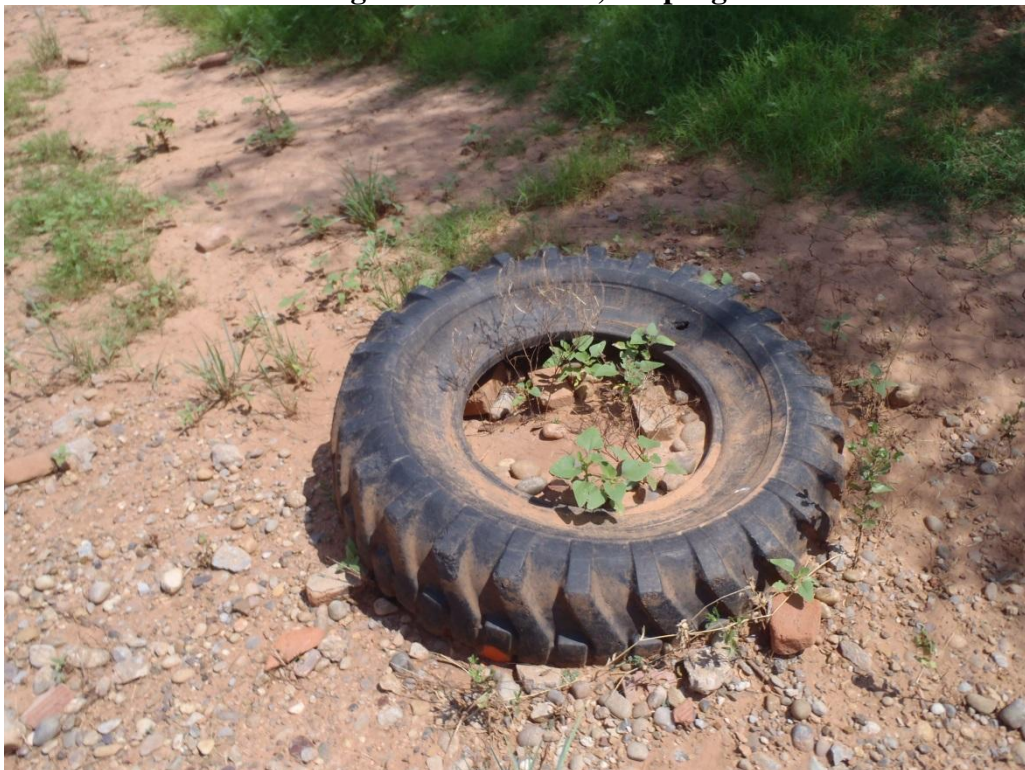
Figure 4.11 Photograph take of PD003 on August 11, 2013. Note tractor tire and brick debris.

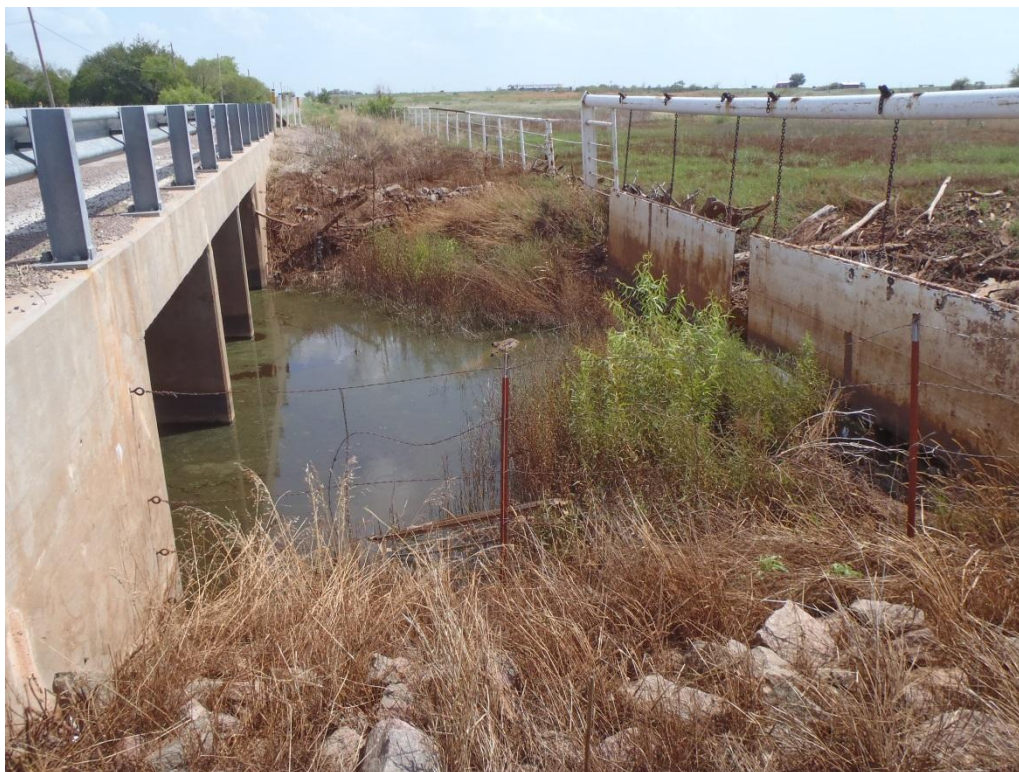
PD004 was surveyed on June 9 and August 11, 2013. Access to this site was only public from the Eagle Street bridge. Getting down to the creek bed was moderately difficult because of riprap on banks, barbed wire fence, unstable log jam accumulations and a substantial steel and pipe water gap which hindered travel through the corridor (Table 4.6 and Figure 4.12). Additionally, once in the stream bed, extremely dense vegetation made traversing the entire 300-m stretch challenging.

Figure 4.12 Photograph taken on June 9, 2013. Public access of the Eagle Street bridge. Note the rip-rap, barbed wire fence, heavy steel and pipe water gap and unstable log jams.

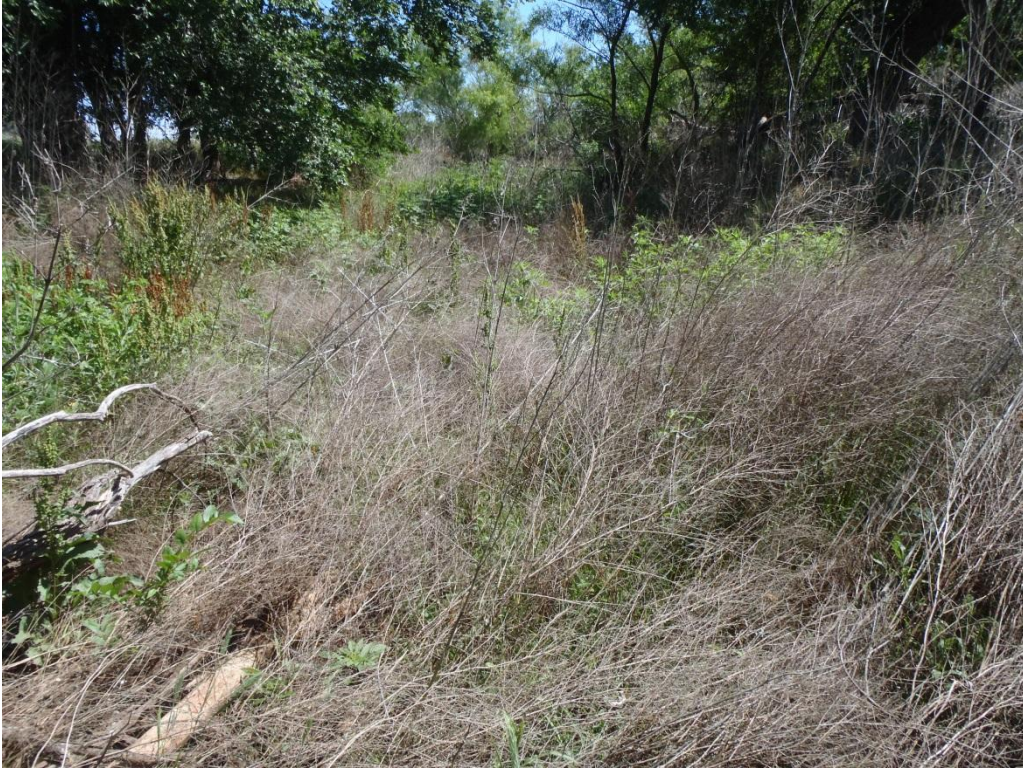
Figure 4.13 Photograph of PD004 taken on June 9, 2013. Downstream view at 150-m transect. Note dense vegetation throughout corridor.

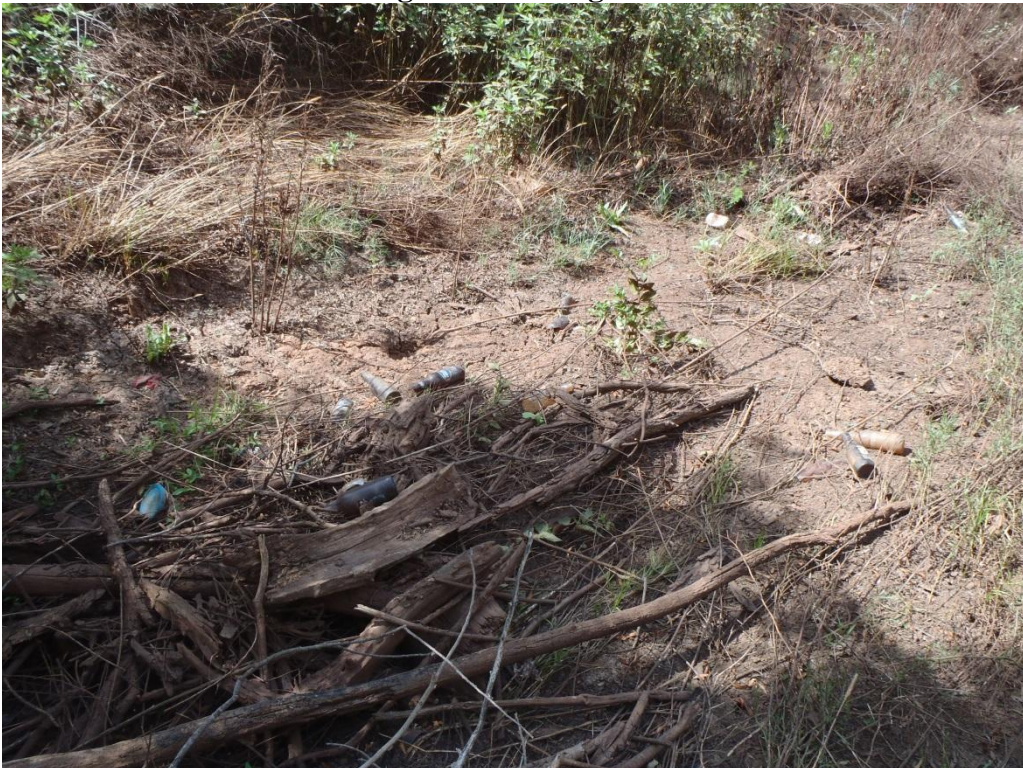
Figure 4.14 Photograph of PD004 taken on August 11, 2013. Note concentration of garbage in streambed and log jam debris.
